# MANALAPAN LAKE DAM

NJ 00293

## PHASE 1 INSPECTION REPORT NATIONAL DAM SAFETY PROGRAM

April, 1979

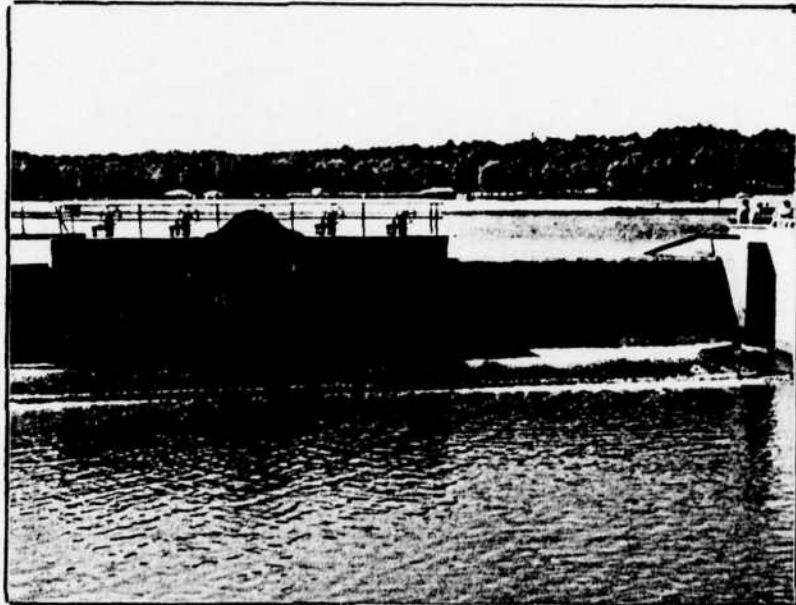
Downstream view of dam

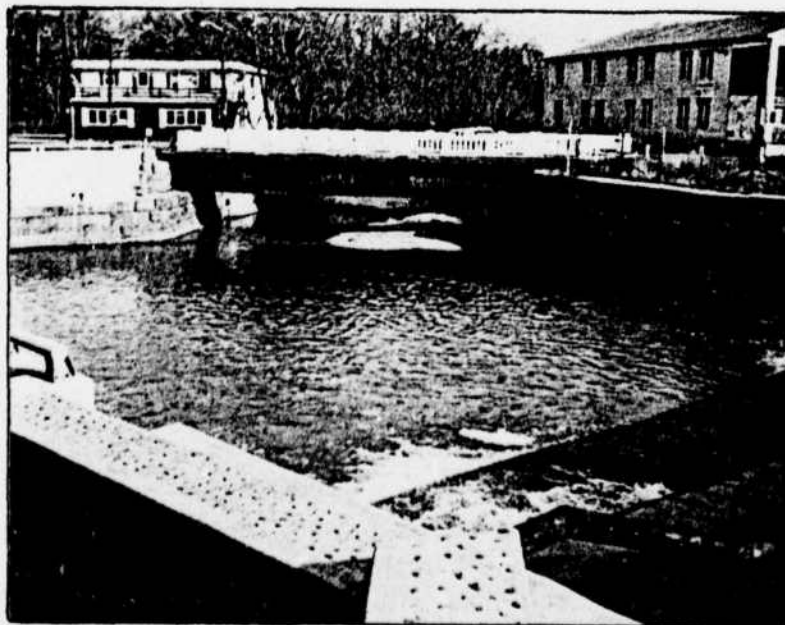
As verified by local residents, considerable downstream areas on both sides of the riverbed are flooded when the reservoir banks are overtopped, which reputedly, occurs quite often. The extent of damages normally sustained is unknown. Railroad Avenue, which runs parallel and just south of the track below the left abutment is well below the dam crest. The downstream channel has between 6 and 7 feet of headroom under the low steel on the bridges but as reviewed in Section 5, appears to have adequate hydraulic capacity, although there is a large accumulation of sand and gravel immediately under the bridges. This appears to require periodic removal.

View of bridges downstream from dam

(1) Remove the deposited granular material from under the bridges.

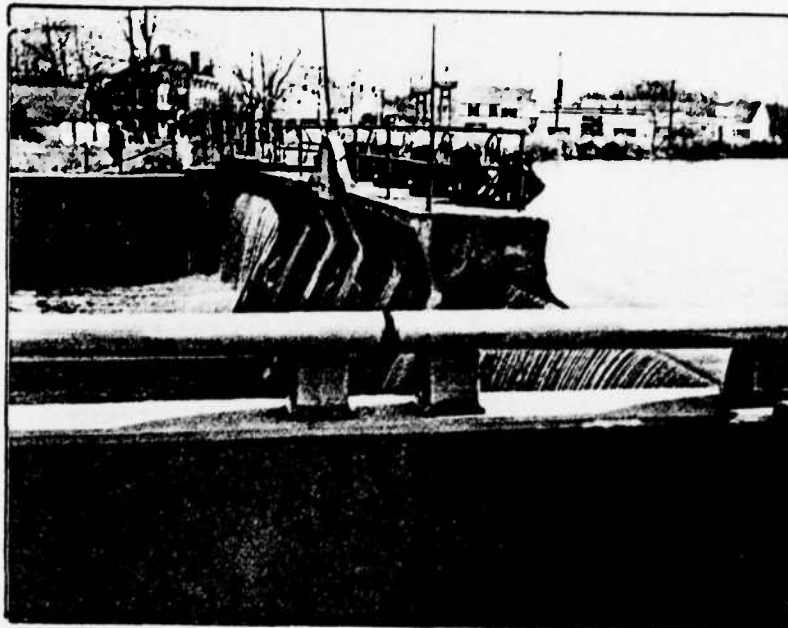
The two sections of the concrete ogee spillway show some minor surface cracking, but the 1957 shotcreting and gunite repairs appear to be satisfactorily sealing the previously spalled surfaces. There is some spalling on the east spillway abutment and channel wall and a portion of the footing is undermined near the end of the apron slab. The gates appear in a satisfactory condition with the exception of the easterly gate control mechanism which lacks a rack and has chipped teeth in the pinion gear. The hand railing and vandal fencing is in satisfactory condition, with the exception of the portion at the right end which needs repair. The downstream spillway apron is roughly 22 feet in width and is approximately 10 feet below the spillway crest. This was reconstructed in 1957 as a considerable portion had been undercut and broken up. Its present condition is suspect due to the high exit velocities of the 48" gates. The left retaining wall is in excellent condition as it is only a few years old, but the right wall has suffered bad structural cracking which extend clear through the stem in some areas.

View of spillway

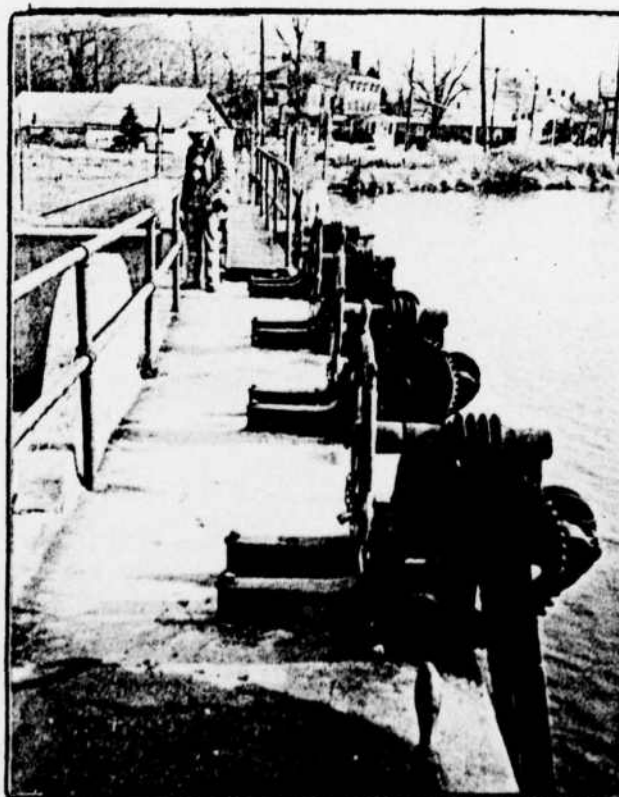
The five sluice gates were last repaired during the 1957 rehabilitation. Presently, one gate control is lacking a rack for the pinion gear while a second is reputedly difficult to operate. No plans have been formulated for the repair of these facilities at present.

View of sluice gate controls

(2) Repair the inoperable gates.
